Nils Engberg, Jørgen Frandsen

Engelsborg – a fortified naval shipyard on Slotø in Nakskov Fjord

Engelsborg on Slotø: Shipyard, castle and administrative center

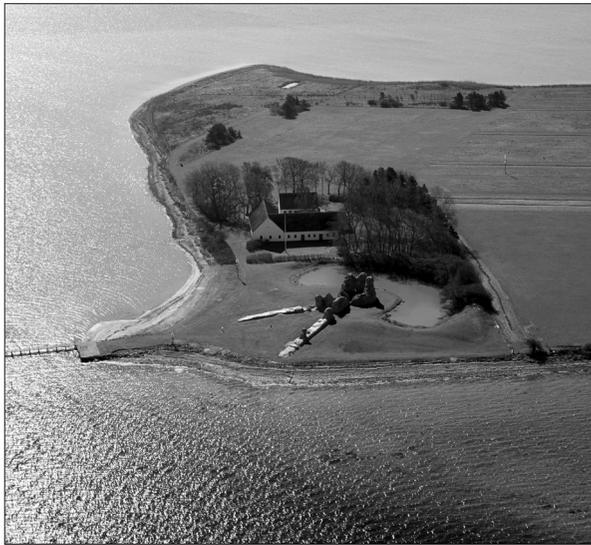
Fig. 1. The ruins of the fortified shipyard Engelsborg photographed in the spring of 2006. The walls have been restored, with interruptions, from 1985 until 2005. The inner moat is well preserved, as is part of the surrounding rampart. The outer moat, on the other hand, has almost disappeared. The farm in the background lies where the commandant, soldiers, shipbuilders, and the other staff had their living quarters right from the start of Engelsborg's history. Photo: Jan Kofod Winther.

On the little island of Slotø in Nakskov fjord there lays a ruin, now completely restored. (Fig. 1). It is not the most visited place because one must either have a boat to get to the island or go on a tourist trip with the mail boat from Nakskov. But it is certainly worth the trip: it is not only the most extraordinarily well-preserved ruin by Danish standards, but also includes visible remains of completely free-standing outbuildings to which no parallel has yet been found in Europe.

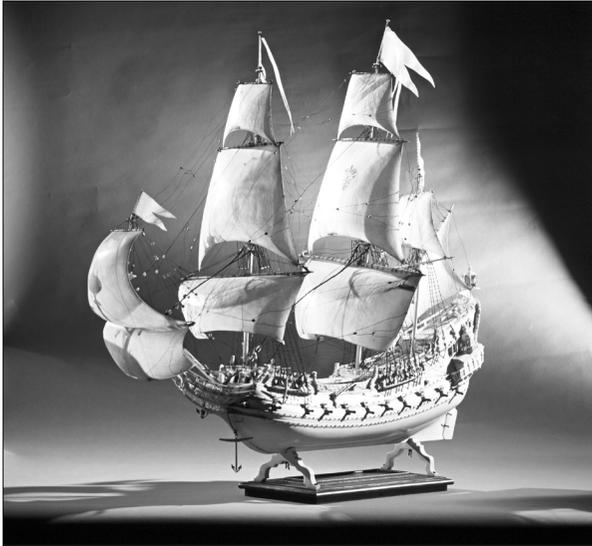
Fig. 3. In the Royal Danish Collections at Rosenborg there is a model of “Norske Løve”, the last naval vessel to be launched from the shipyard on Slotø. The model was made in 1652–1654 in ivory and silver and is one of the world’s costliest ship models. According to the accounts, 82 kg of ivory were used for the 95 cm long model. Photo: Rosenborg Castle.

Between 1549 and 1623, we hear very little about Engelsborg or Slotø, but then something happened again. Christian IV decided that once again ships should be built on Slotø and it was done: from then until 1633, ten large naval vessels were launched from Slotø. The last one is assumed to be "Northern Lion" (Fig. 3) (Hansen 1948a).

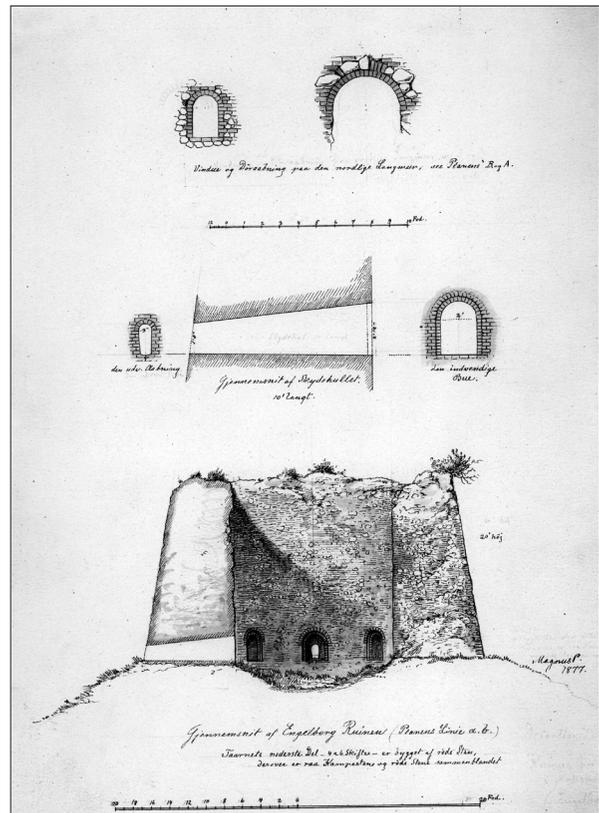
Fig. 4. During his inspection of the castle ruin on Slotø in 1877, Magnus Petersen sketched among other things this section through the tower and details of embrasures. Ill: The National Museum.

to the island and from his visit we get the first actual documentation of the site (Fig. 4).

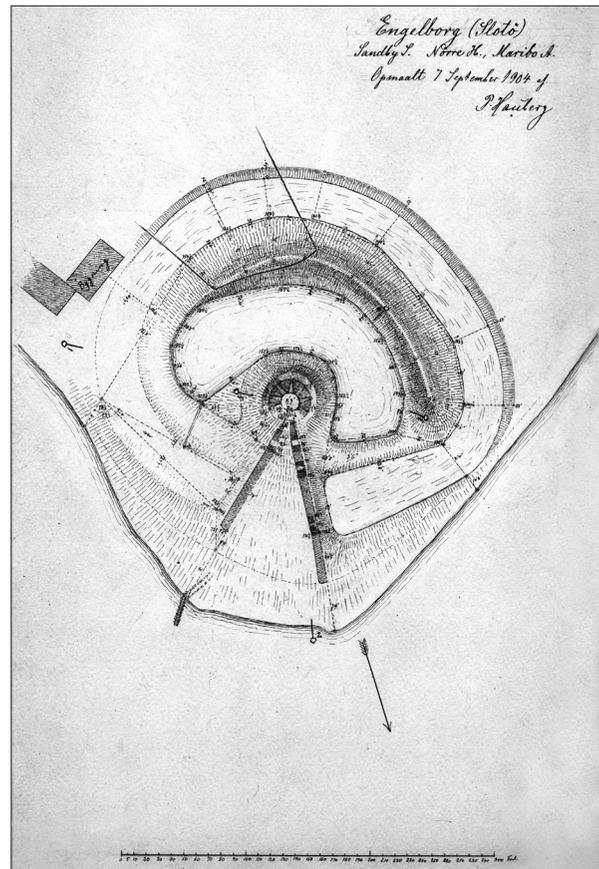
Fig. 5. In 1904, the ruins with the surrounding moat and rampart were surveyed. It is worth noting that at such a late point in time it was possible to see or glimpse the outer moat, which is today as good as gone. Ill: P. Hauberg, The National Museum.

In the first part of the 20th century, the island was inspected several times by, among others, Peter Hauberg from the National Museum who in 1904, as part of a nationwide inventory of moated sites, undertook a regular survey of ruins, which had moats or ditches (Fig. 5). In many cases there was a wish to undertake an archaeological

The excavations took place in summer for four seasons and the workforce consisted of school students. In the first year, they came exclusively from the local Grammar school in Nakskov, but in the following year students from all over the country participated and in the ensuing two years they also came from Norway, Sweden and Holland. The excavations were carried out under the supervision of the National Museum, but it was Marius Hansen who was the real leader of the investigations. A considerable part of the excavation consisted in digging out the ruins from the piles of earth. It became clear that the tower and so-called flank walls were built together and thus had been part of one and the same construction. He stated that the round tower had a diameter of 12 metres – it is 10.9 metres now – and the walls were 3.5 metres thick (now 3.3 metres). There are nine canon-loops in the tower's lower storey. The tower room is 29 square metres, enough to enable people to move around when the rather modest cannons were to be fired. The canon-loops are very narrow on the outside (14 cm wide and 35–40 cm high) but strongly bevelled so that canons could be placed on a recoil beam fastened on the wall at the side of the opening. The loops are arranged in such a way that from here one cannot fire over the encircling rampart, but it was the attacking enemy one was supposed to hit, on his way down into the moat or over the ditch and most vulnerable. The further reaching defence was carried out from the floor above. A spiral staircase built into the wall led up there and Marius Hansen found faint traces of two canon-loops (Fig. 5).

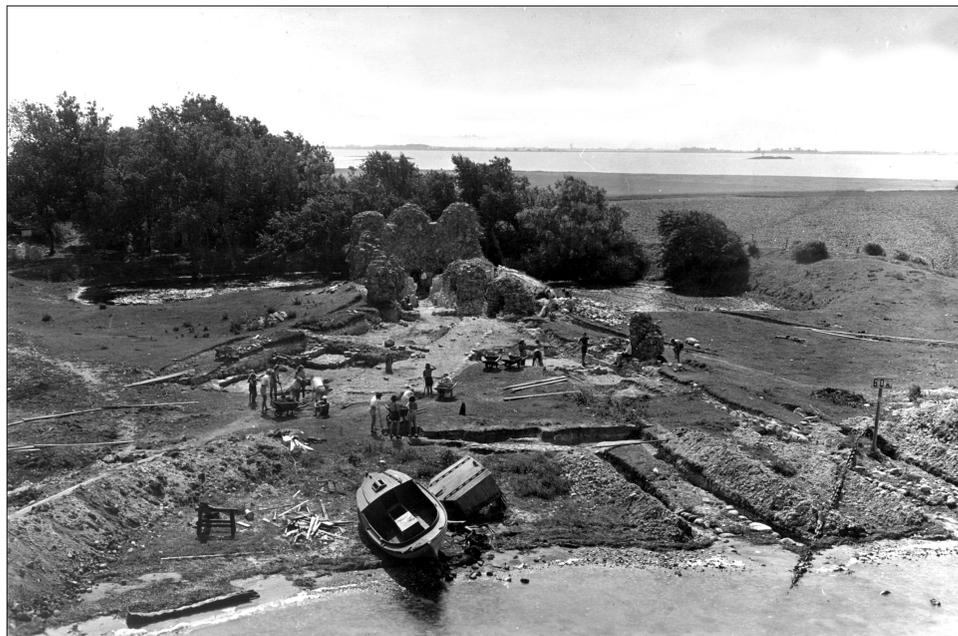
Fig. 6.
After exposing the walls in summer 1944 archaeologists began in 1945 to excavate the shipyard in the area between the flanking walls. The photo was taken from the deck of one of the freighters that lay at anchor in the fairway off the ruins. Photo: M. Hansen, The National Museum.

foundations and floors in several buildings, and a tar cauldron among other things (Fig. 6). The many interesting remains of buildings connected to the shipyard will not be discussed here. We shall focus on the fortifications instead. A couple of observations are, however, important for understanding of Engelsborg's building history if we compare them with later excavations. While digging at

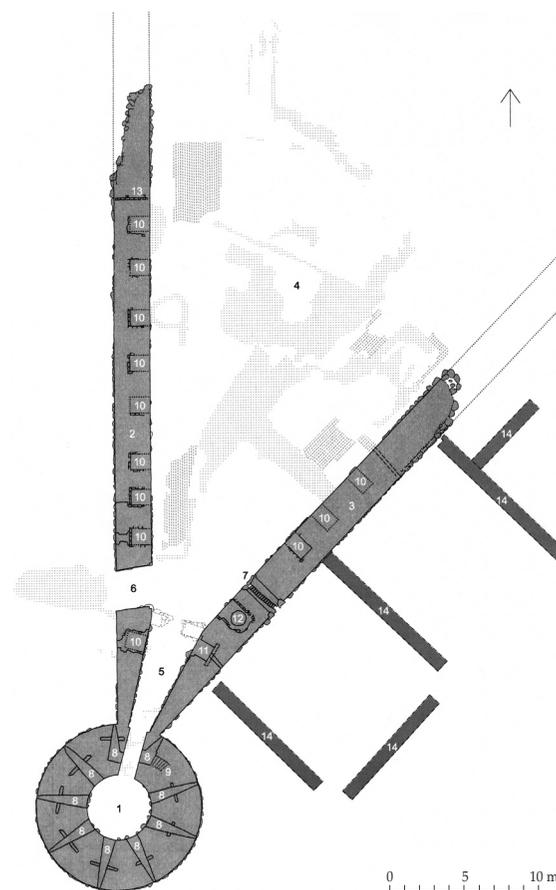
Fig. 7.
1. The main tower had at least two storeys and was probably crenellated (with open embrasures) on the top storey.
2. The western flanking wall, which was probably crenellated on the second storey. The wall probably stretched about 15 metres out into the water. 3. The eastern flanking wall presumably also had crenellation. The wall probably stretched out into the water, but only for a few metres, since at this point there is deep water in at the coast. 4. Marius Hansen's excavated foundations, brick floors and paving of the naval yard. After registration, the finds were covered up again.

5. The antechamber to the tower. 6. The gate was originally vaulted. 7. Doorway with sewage channel below. 8. Canon-loops on the first floor of the tower. 9. Staircase to the second storey. 10. Preserved traces of canon-loops in the flanking walls. 11. Partially reconstructed canon-loops. 12. Well. 13. Temporary termination of the wall. 14. Sondage trenches dug in 2005.
Ill: S. Brandt, N. Engberg, J. Frandsen, The National Museum.

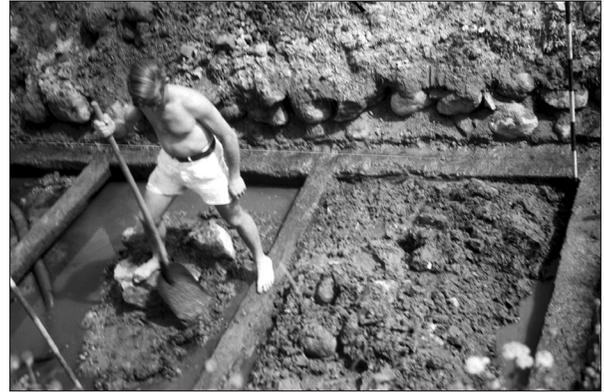
Fig. 8. On the outer side of the western flanking wall Marius Hansen found a timber structure “situated about one metre below the mean sea level.” The structure with its large oak beams was the first trace of the western careening place. Photo: M. Hansen, Lolland-Falsters Stiftsmuseum.

up to 1/2 metre in size. Westwards and in line with the wooden construction found on the shore, there lay four heavy and wide oak planks ending on the western end with a piece of a square wooden construction like the one used for the “caisson” on the shore (Fig. 8). It was held in place by a 0.6 metre wide layer of stones. Six metres further out another wooden construction was found, this time with both sides intact. On the other hand, there was no further trace of the three-metre wide layer of stones. As previously supposed, it must end about 15 metres from the present coastline. So the west flank wall may have had a total length of about 66 metres, but it is uncertain, whether the wall was built right out or whether its course stopped further back and continued with a jetty. The wooden construction outside had functioned as a foundation for a careening place. Here the ships were careened, that is laid on their side for repairs or maintenance. It required a hefty pull to careen the big warships. The strong wooden construction anchored on the land allowed this to take place.

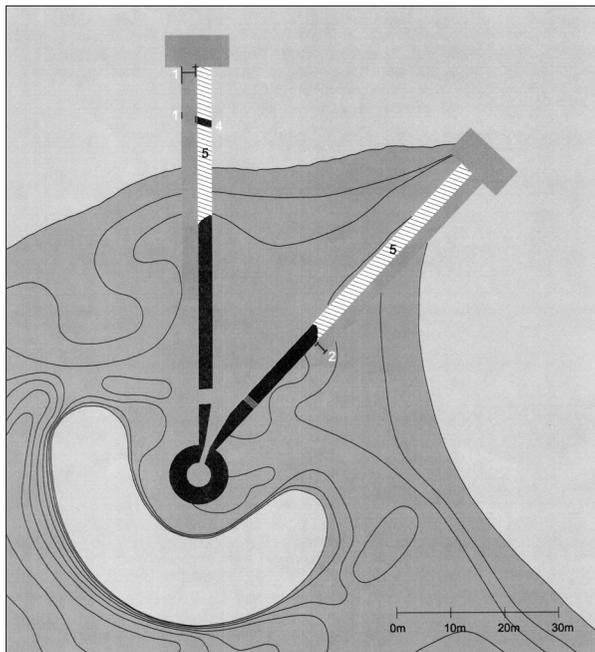
Fig. 9. Plan of Engelsborg indicating the full length of the flanking walls and the careening place. 1. Red shows the wooden structures from the western careening place, which was investigated in 1985. The location of the timber structure that Marius Hansen found in 1946 is not indicated because of uncertainty about the exact spot. 2. Wooden structure belonging to the eastern flanking wall, excavated in 2005. 3. The extent of the western careening place was established by excavation. The eastern careening place is sketched in as a mirror-image copy of the western one. 4. The foundations of the wall, excavated in 1985. 5. The length of the western flanking wall was established by excavations in 1946 and 1985. The length of the eastern flanking wall is sketched in as a copy of this. Ill: S. Brandt, N. Engberg, J. Frandsen, *The National Museum*.

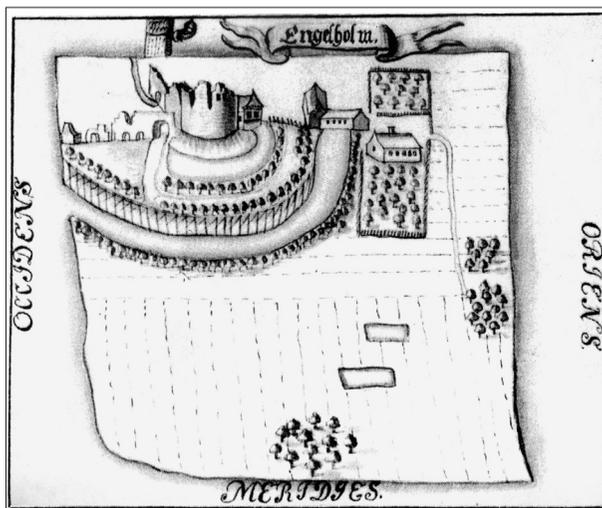
Fig. 10. Engelsborg ("Engelholm") c. 1680. Perspective drawing from Resen's Atlas. Note the building which looks as though it lies close up against the eastern side of the castle complex. The excavation in 2005 showed that it could not have been a brick building; it was probably all-wooden houses or half-timbered buildings for use in shipbuilding in 1623–1634.

In total, five exploratory trenches were dug east of the east wall (Fig. 10). Three of them were set at right-angles to the wall as it is here that a large building can be seen

on Resen's Prospect and the foundation or traces of such a building should be visible in the trenches. There were, however, no traces of the foundation to be seen here. So it is certain that there was no large thick-walled building here, as was the impression from Resen's Prospect. On the other hand, we found that a thick layer of debris consisting of fragments of tile and boulders bearing traces of mortar had been placed in the area outside the wall. This area was obviously made ready for building, which can only have happened when the place was again to function as a shipyard in 1623. We can imagine that, at that time, both the tower and the flank walls had been left in a state of disrepair, apparently since 1549, when Engelsborg was no longer a castle for a king's bailiff. The upper section of the walls may very easily have fallen down by themselves, though it is not so conclusive here, since, evidently, it must have been decided to demolish the upper part of the walls – so this is the core of the walls
