### Restorations in 1985–2005 (Engberg and Frandsen 2006)

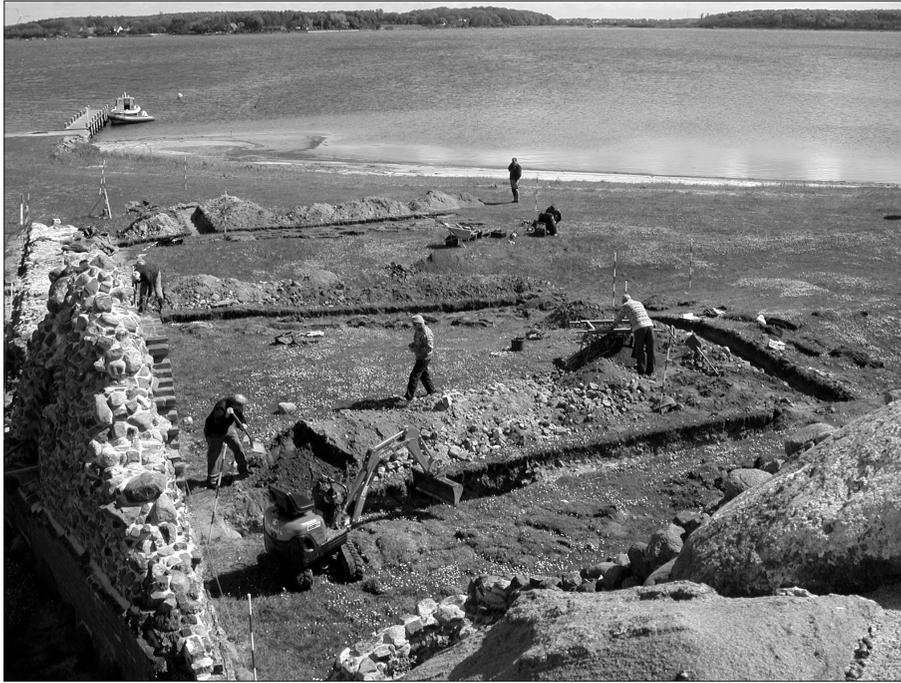
Fig. 11.

*In connection with the conclusion of the restoration work in 2005 a minor archaeological investigation was conducted: five sondage trenches were dug in the area just east of the shipyard. Bente and Knud Christiansen and Hans Ole Hansen from the Lolland-Falster Amateur Archaeology Society are to be thanked for their dedicated help. Photo: N. Engberg, The National Museum.*

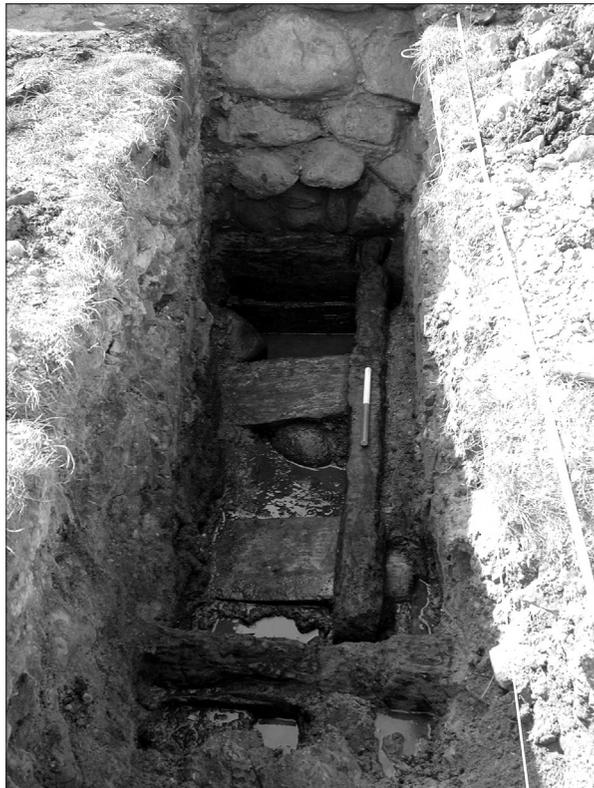
Fig. 12. On the outside of the eastern flanking wall at a depth of one metre there lay a large wooden structure which helped to stabilize a careening place – the platform out in deep water where the ships could be careened, i.e. turned on their sides during repairs of the bottom and sides. Photo: N. Engberg.

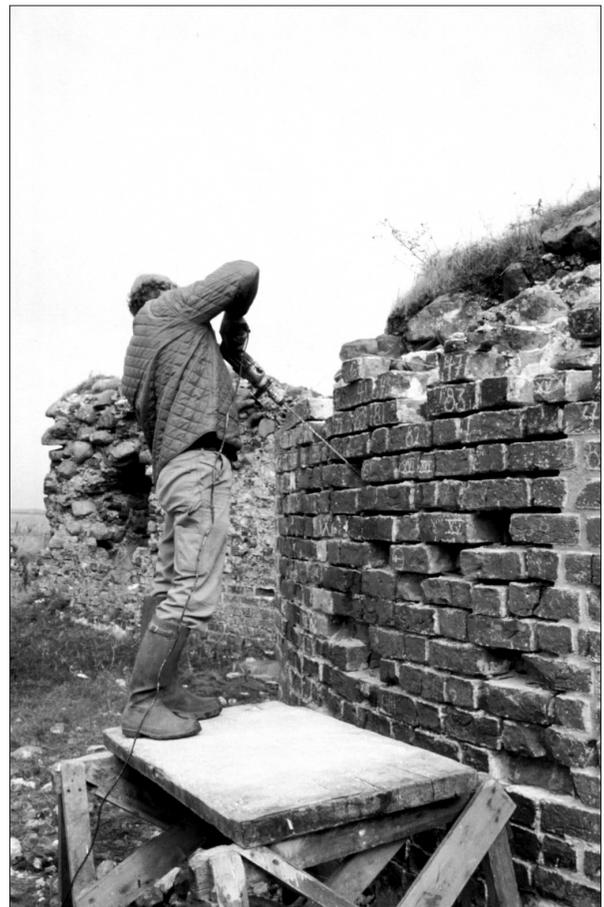
Fig. 14. The master mason Johan Henriksen drilling in the wall core to mount the masonry anchors. The masonry anchors fix the original facade wall to the wall core. The facade bricks are numbered, so that bricks that have been removed can be reinstalled in their original places. Photo: J. Frandsen, The National Museum.

The restoration work on Engelsborg began with stabilising the wall facings of the tower so as to preserve as much of the original wall as possible. As mentioned, the wall facings had come loose from the core and in order to provide an anchor, some of the broken ties were temporarily removed so that stainless steel anchors could be bored into the wall core. To stop water penetrating in

the gap between the facing and the core, the top course was bricked up so that the gap was sealed off. Finally, the facing was pointed with a mortar separate a little from original mortar. The section that had fallen down was reconstructed from the clear traces of the run of the brick courses on the wall core.

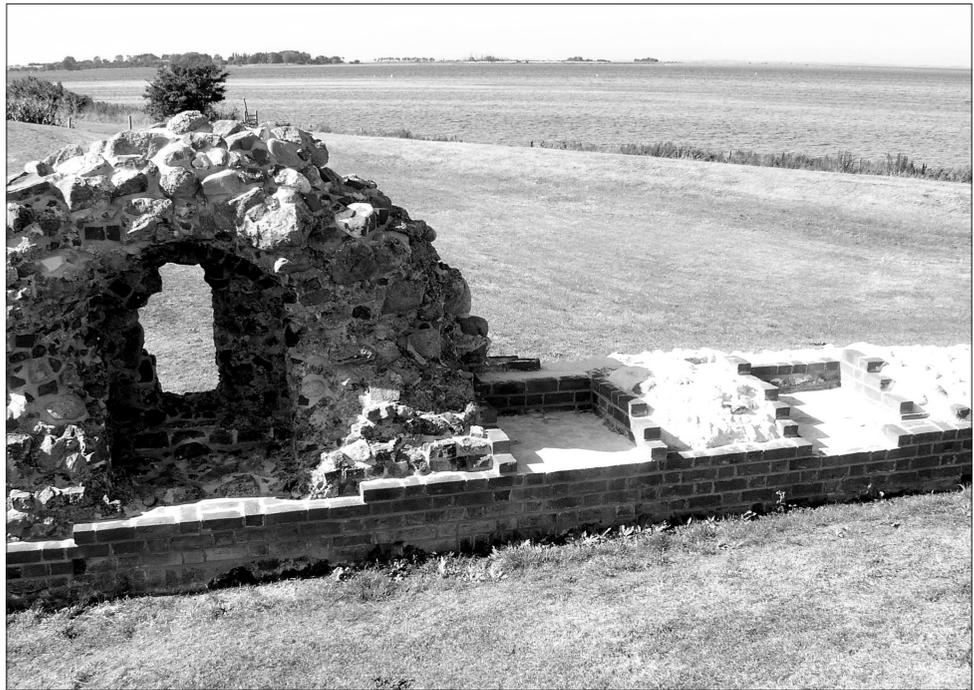
Fig. 15. Canon loops in the western flanking wall after repairs. The original, high wall core has been waterproofed. New medieval-style bricks have been laid on the facades of the flanking walls and in the poorly preserved canon-loops. The new bricks have been placed in accordance with reliable traces in the mortar. Photo: J. Frandsen, The National Museum.

The gun-loops at first-storey level had almost entirely disappeared. They were only visible as an impression of the mortar from the missing bricks together with a few remaining cracked bricks in the wall core. After careful cleaning and subsequent measuring up, it was possible, with two of the gun-loops, to reconstruct parts of the lowest courses as well as the mortar base of the gun-loop. Originally, there must have been six gun-loops on the first storey of the tower. The nine gun-loops on the lowest storey had barrel vaulting and a recoil beam was situated in another course over the mortar base. The gun-loops on the first storey seem to have been constructed like those below; however, no recoil beam could be perceived in the preserved core. The recoil beam was perhaps only lightly cemented into the wall core as is also the case in one of the lowest gun-loops.

In all, traces of 14 gun-loops are preserved in the two flank walls. In ten of these only the loop's base or parts of the lowest courses remain in place or traces of mortar that indicate where they were originally situated. Loose bricks were cemented up and subsequently the sides of the gun-loops were reconstructed following the preserved traces of mortar. The broken down bases were renovated so that the rain penetration could be minimised. An interesting detail of construction could be seen in the gun-loops. One brick was set in the core level with the base and placed such that it could be used to set up the bricklayer's string when the first course of the sides of the niche was to be laid.

The flank walls' original facing has remained at the height of a few courses only. During the restoration, new brick courses were cemented on top in order to secure the facings. The bricking up also secures the core of the wall that lies behind. The top of the wall was secured with a "sacrifice layer" consisting of material matching that of the original core. In order to be able to reconstruct the brick courses over the wall facing the remaining broken brick ties, which could still be seen in the core, were registered and from here on it was possible to continue bricking with the original bond.

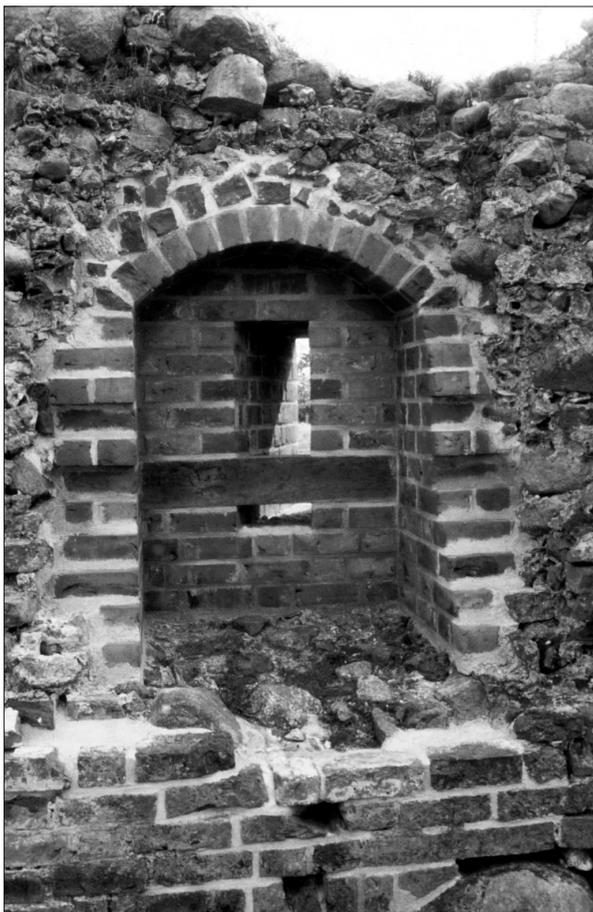
Fig. 16. The inner side of the partly reconstructed embrasures with a recoil beam. When the embrasures were originally used, the beam absorbed the recoil from the arquebus, which had a hook that engaged with the outer edge of the beam to absorb the recoil. Photo: J. Frandsen, The National Museum.

In the anteroom to the tower in the eastern wall it was possible to reconstruct the gun-loop in its full size, from the preserved traces of building supplemented with details from the two best-preserved gun-loops in the west wall. The gun-loops in the flank walls are constructed in a very different way from those in the tower. They consist of a 1.1 metre wide and 1.5 metre high niche arched circa 0.6 metre above the inner base and finished at the top with a round arch. In the outer wall of the niche sit three brick courses over the base of a narrow bevelled gun-loop. The recoil beam is placed in the loop's bevel, flush with the inner side of the niche. New brickwork in the gun-loop and on the south wall facing around the gun-loop was undertaken only in the area where it was considered necessary to stabilise the original brickwork. A recoil beam was again set in the gun-loop. The new brickwork stabilised and also provided the opportunity to give a better impression of the sidewall's gun-loops.

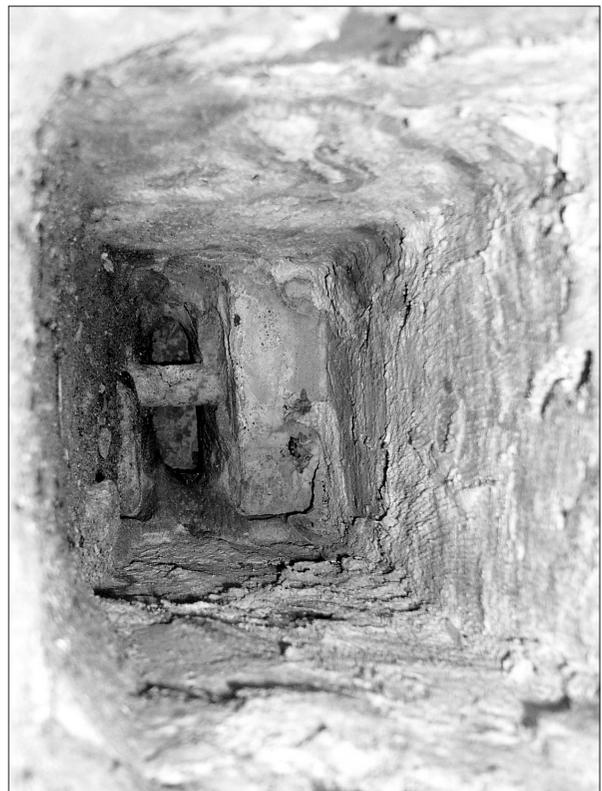
Fig. 17. A look into one of the holes where the recoil beams were originally placed. The wood has long since rotted away, but the preserved impression of the beam in the mortar reveals that the timber had a scarf on the inside. One can see that the bottom part of the timber was the longest. The timber joint would have been made with a mortise. The hole was filled with mortar when the timber was built into the embrasure, and can now be seen as a free-standing mortar cylinder. Photo: J. Frandsen, The National Museum.

Engelborg's original recoil beams have long since disappeared and today only the holes remain. If one looks

more closely at these holes, one can see that part of the original beam used recycled timber. This can be seen in some of the tower's beam holes where an impression of the wood has been left in the mortar. Some of the pieces of wood had dowel holes and in one of the western flank walls there is an impression in the mortar of a lengthwise groove in a piece of timber measuring 18 × 28 cm. The groove is on one of the broad sides of the timber. It has an upper width of circa 4 cm, a lower width of circa 2.5 cm and a depth of circa 5 cm. The side that has the groove in it has slightly sloping sides with rounded corners. There was probably a corresponding groove on the other side of the timber. This recycled timber may originally have come from a wooden house where it was one of the upright posts into which the horizontal planks were dropped.

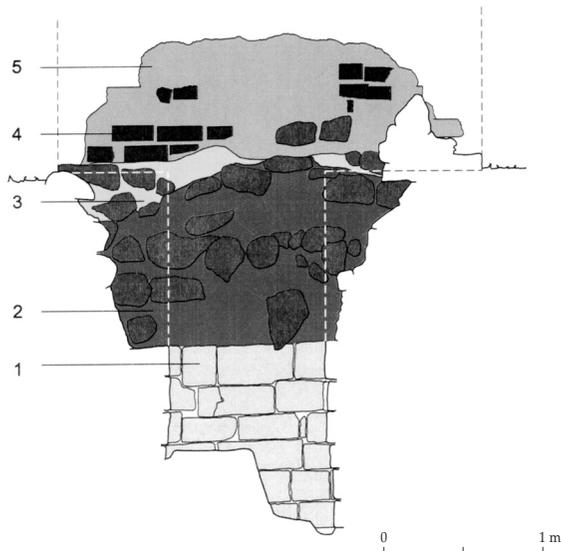
Fig. 18. Cross-section through the eastern flanking wall showing the preserved part of the placing of the well in the middle of the wall body. 1. Cross-section through the preserved part of the well. 2. Demolition layer and parts of the wall foundations. 3. Foundations laid in mortar. 4. Preserved facade bricks in the eastern inside alignment of the wall facade around the well.

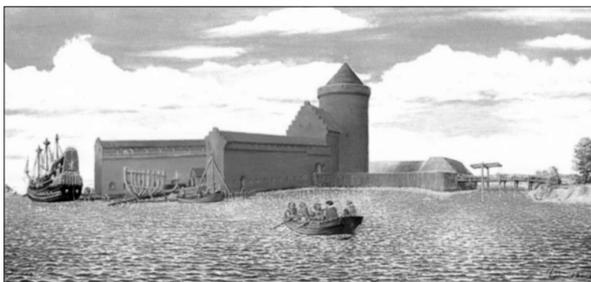
Fig. 19. The shipyard and fortress complex of Engelsborg, as a local artist, Børge Larsen ("the Dairyman") imagined it must have looked in its prime. On the right of the picture, a bridge across the inner moat, and a dam that went on past the inner moat to the gate in the western flanking wall. In the reconstruction the tower has been given three storeys and the flanking walls a closed upper storey. The last of these is a rather unlikely construction, but there were undoubtedly gun platforms of wood up here. The tower is unlikely to have had more than two storeys. The overall impression as rendered here, however, gives a good idea of the imposing sight that must have greeted the seamen of the age when they approached Engelsborg from the sea.
